PROJECT : ICICI BANK ICMC, JAIPUR

CLIENT : ICICI BANK LTD.

AUDIT REPORT

REF. RCCPL - ICICI BANK ICMC, JAIPUR / ICMC JAIPUR /
AR - 036/R1(Dt. 16-09-2024)

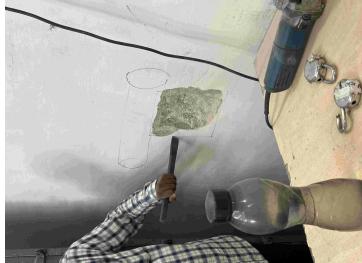
2	This is point number two inside the VAULT ROOM for NDT hammer test and ultrasonic pulse velocity test surface preparation is in process.	2024-08-09	Tests are conducted & results are as per report.

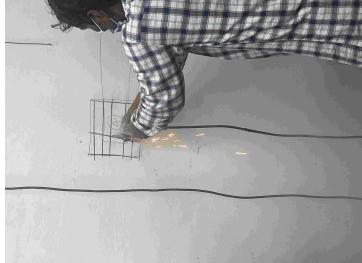
3	This is point number three inside the wall room for NDT hammer and ultrasonic pulse velocity test surface preparation is in process.	2024-08-09	Tests are conducted & results are as per report.

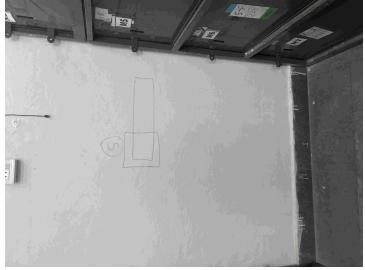
4	Point number four for ultrasonic pulse velocity test inside the vault room on the column surface preparation will be done for conducting the test.	2024-08-09	Tests are conducted & results are as per report.

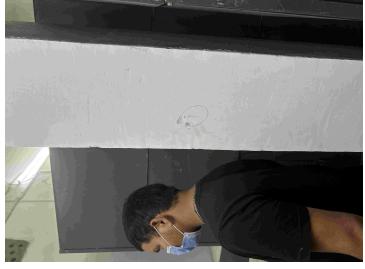
5	This is fifth point for ultrasonic pulse velocity test by direct method. Surface preparation will be done shortly.	2024-08-09	Tests are conducted & results are as per report.

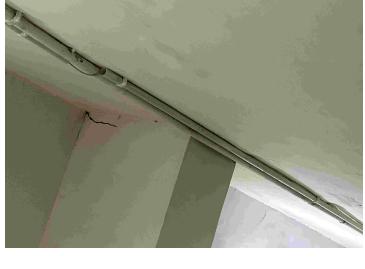
7	<p>This is also the left side corridor of main entry of vault room. The outer wall of this corridor is showing some problems. This is point number one, there is a crack observed in the beam. This crack might be due to the water seepage from ground floor in the beam, which is rusting the beam steel and that's why cracks are being developed, point number two, this is a junction of slab and wall joint where seepage is appearing and this is also likely to be from the other side. This is spoiling inside plaster of the corridor wall point number three due to the seepage which is from other/positive side of corridor outer wall, the plaster of the wall is already started coming out .</p>	2024-08-09	<p>Source of water from the other side of the wall at ground floor level need to be checked and closed. Water entry is strictly to be stopped from outside surface and thereafter the spoiled Plaster is advised to be removed/scrapped out, and then redone with the RMP material.</p> <p>For the seepages from outer wall positive side the crystalline water proofing is advised & see the results for 1 year. Most probably the seepage will be stopped.</p>

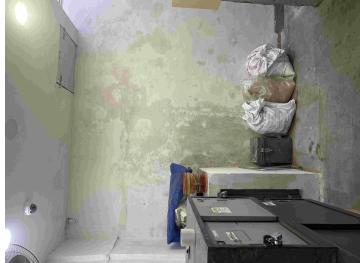
9	In the pic number one is showing the vault room wall and number two is showing the outer wall of corridor. As per the observation, the condition of vault room wall is good, but the condition of outer wall need IMMEDIATE attention on waterproofing and closed cutouts, which are not closed properly & cracks are developed at the edge of these closed cutouts.	2024-08-09	<p>These cutouts needs to be closed properly with a proper joint treatment using fibre mesh before the plaster, so that cracks will not reappear.</p> <p>Crystalline Process Water Proofing is advised to this problem.</p>

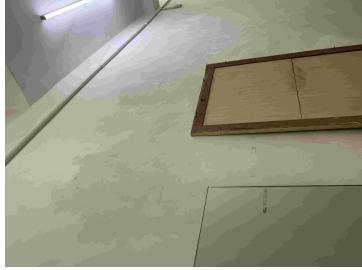
11	This is the ceiling portion of corridor at the rear side of vault room where the beam is showing crack. That means from somewhere from the ground floor level water has started entering into the beam and slab portion and that is causing rusting of steel. If it is not attended immediately, then in the coming time, a huge refurbishment cost will required to be incurred.	2024-08-09	First of all, the water entry from the ground floor or from the outside filled up soil need to be stopped and thereafter initial level refurbishment processes advised.

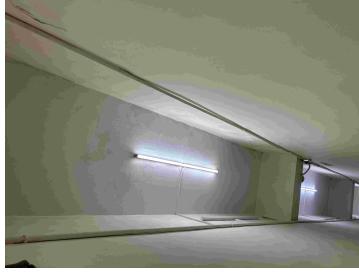
13	This is right side corridor of the vault room where above skirting seepage problem is also observed. It is said that the other side of this corridor outer wall there is a filled up soil so it seems difficult to treat this water source from the outside and hence something will have to be done from the negative side only inside only & that is CRYSTALLINE PROCESS of water proofing.	2024-08-09	Crystallisation method of Waterproofing is advised.

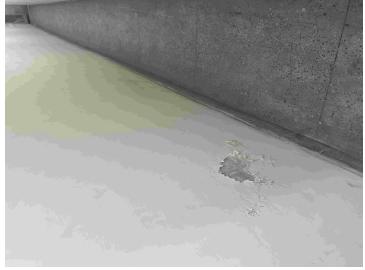
14	This is right side corridor, outer wall of the vault room where a huge horizontal crack is observed. This crack might be at the masonry and RCC beam joint. Also it can be due to the outer side filled up soil water coming inside and rusting the beam steel rods.	2024-08-09	Outside water source need to be closed first, and then from inside this is to be repaired after scrapping out of entire damaged plaster with a new RMP material. Before doing the new plaster using RMP, the crystalline water proofing process is advised on the entire corridor outer wall inside surface.

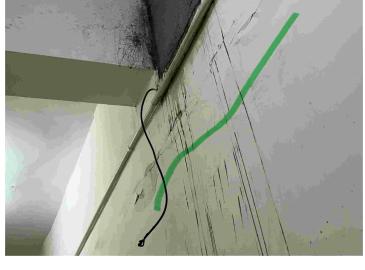
15	This is also in the right side corridor of vault room where a cutout in the outer wall is closed with some ply board or something, which is not advisable. It is showing crack all around the cutout. There are number of such cutouts are closed improperly in the corridor outer wall, and this also becomes a weak point for the vault room safety.	2024-08-09	It is advised to close all the cutouts with the proper construction sequence and methodology using fiber mesh before plaster at the joint of cutout and adjacent wall.

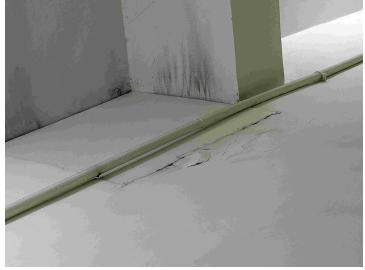
16	This is corner of the vault room corridor towards the right side of the vault room main entry where, above skirting seepages are observed too much, and this is causing spoiling of the putty paint and plaster work done. This also results in recurring expenses.	2024-08-09	Outside source of water need to be closed properly & if it is not possible, then inside crystallisation process of waterproofing is advised.

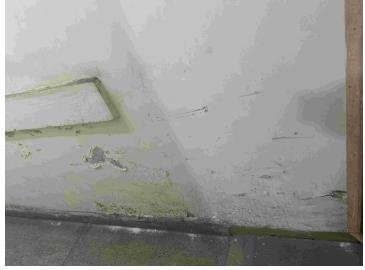
17	Near the vault room & inside the Guard Room, the backside wall is showing huge seepages. It might be due to the fill up soil outside.	2024-08-09	Negative side, waterproofing treatment is advised using the crystallisation process.

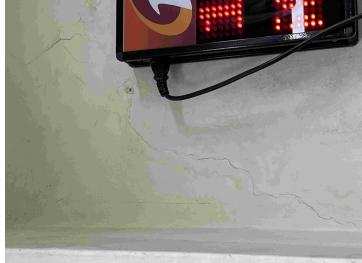
20	This is also process room, the left side corner on the rear wall showing a vertical crack.	2024-08-09	Crack therapy is advised.

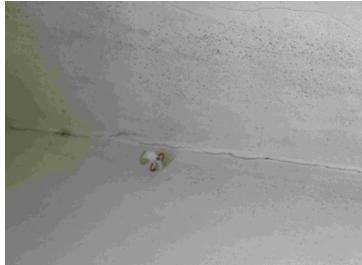
21	This is also process room in the left side corner ceiling is showing crack. It seems the POP done here is cracking.	2024-08-09	It is advised to use POP fibre net/jali treatment at the joints.

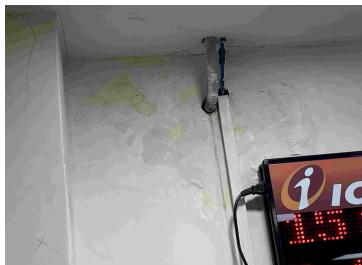
23	This is also processing room inside on right side wall is showing a horizontal crack below the ceiling. It seems this is the junction of beam bottom and the masonry level. This type of situation happens when the joint is not treated properly.	2024-08-09	Advised removal of this cracked portion both side of the crack 3 to 4 inch for entire length of crack and check whether the crack is in plaster or it goes through the masonry, and accordingly, the type of crack therapy therapy will be decided.

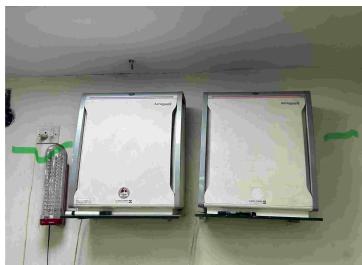
24	This is also processing room inside right side corner on the backside wall. A horizontal crack is observed. It might be due to the improper joint treatment of masonry and concrete.	2024-08-09	Crack therapy is advised.

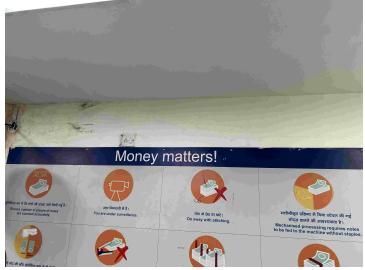
25	This is change room beam portion which is cracking from the bottom. It seems from somewhere water is entering and steel has started rusting inside the beam and that's why this crack is causing. In case it is not treated immediately, then it may further damage the beam and lead to huge refurbishment cost in coming time.	2024-08-09	First, stopping the water source and then scrapping out and checking the beam portion if the steel is still in condition, then it is to be treated with the Structural motor. And if it is observed steel has rusted 30-40% then refurbishment shall be done.
